## **Full Mouth Rehabilitation: A Multidisciplinary Approach**

**Nur Laila Sofia Ahmad**

Faculty of Dentistry, University of Malaya, Malaysia.

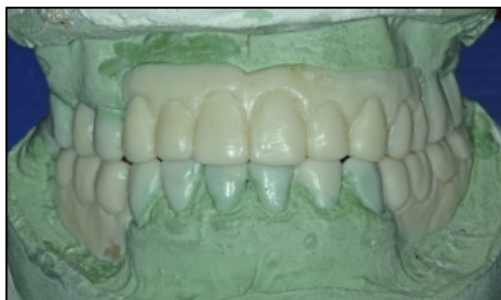
Figure 4 Diagnostic wax up at an increased occlusal vertical dimension

Occlusal analysis was carried out and facebow transfer (ARCUS<sup>®</sup>, KaVoDental GmbH, Biberach, Germany) recorded. Study casts were mounted on a semi adjustable articulator (PROTAR<sup>®</sup> evo 5, KaVo Dental GmbH, Biberach, Germany) at centric relation. A diagnostic wax up at 4mm increase of occlusal vertical dimension was done, which served to guide the clinician and to help the patient visualize the treatment outcome. The treatment plan was developed with the following aims: (i) to restore masticatory function, (ii) to improve aesthetics, (iii) to conserve the remaining dentition and (iv) to maintain health of supporting structures. In the mandibular arch, fabrication of full ceramic crowns for anterior teeth and implant retained bridges to replace missing posterior teeth were planned. Chrome cobalt overdenture was planned for missing teeth replacement on the maxillary arch. Remaining maxillary teeth were to be utilized as overdenture abutments.

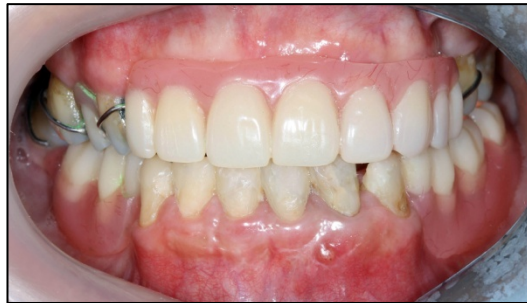
Figure 5 Provisional overlay denture in-situ at diagnostic stage. Improvement in appearance is apparent

Restorations were planned from first molar to first molar only, adapting the shortened dental arch concept, as they were enough for function<sup>1</sup> and easier for patient to maintain. A diagnostic stage was carried out by providing an upper overlay acrylic denture at the planned increase of occlusal vertical dimension. It serves as an interim prosthesis, to evaluate the aesthetic outcome and to assess the patient's ability to tolerate the proposed increased vertical height. The overlay denture was worn daily for the first three months. Development of temporomandibular joint disorder were negative after several months of observation and patient was deemed prepared for execution of the planned definitive restorations. The interim prosthesis was subsequently worn throughout the course of treatment, fitting adjusted whenever necessary.

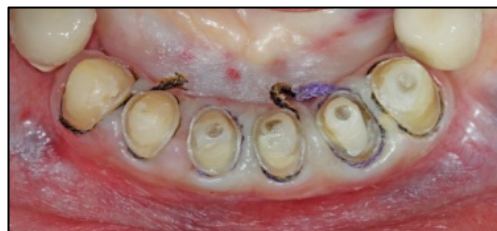
Figure 8 Crown preparations on tooth 33 to 43 with retraction cord in place

Crown preparations from tooth 33 to 43 were done after construction of implant bridges were completed. The prepared teeth were restored with highly aesthetic lithium disilicate full ceramic crowns (IPS e.max<sup>®</sup> Press, Ivoclar Vivadent, Schaan, Liechtenstein). Upper arch reconstruction was started with preparations for milled telescopic crowns on 16, 14 and 26 and metal copings on 22 and 23. This was followed by construction of removable prosthesis. At completion, the overdenture was fitted and necessary occlusal adjustments were made and then returned to the laboratory for construction of metal occlusal surfaces on 15, 24 and 25. The occlusopalatal surfaces of the denture were cut back, the original cusps were rebuilt with resin pattern and casted in nickel titanium metal. The prepared metal casts were adhered to the respective occlusal surfaces with resin cement (Panavia F<sup>™</sup>, Kuraray Medical, Okayama, Japan). The buccal surface of tooth 14 on the overdenture was then veneered with zirconium silicate indirect restorative material (Ceramage<sup>™</sup>, Shofu, Kyoto, Japan).

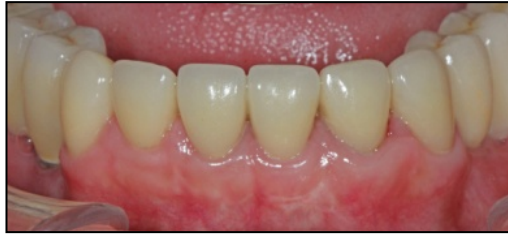
Figure 9 Cemented lithium disilicate full ceramic crowns on tooth 33 to 43

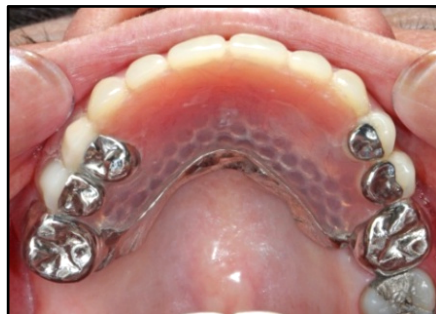
Figure 11 Cobalt-chrome overdenture with metal occlusal surface on posterior teeth.

Dislodgement of metal copings on the posterior occlusal surface of the overdenture is prone to happen in presence of even the slightest occlusal disharmony as its retention depended solely on resin bonding. Another option available is to incorporate it in the metal framework. The posterior

occlusal surface of the overdenture had to be in metal because it was opposed by comparatively highly abrasive porcelain in the occlusal surfaces of mandibular posterior fixed prosthesis selected by the patient for aesthetic reasons.

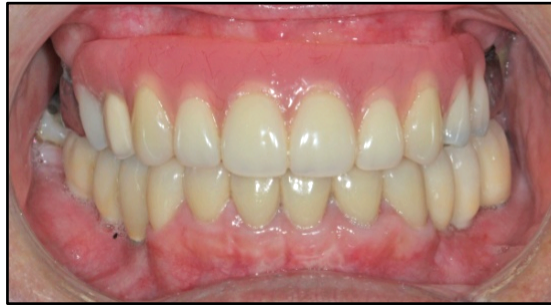
Figure 12 View of the completed combined fixed and removable restorations

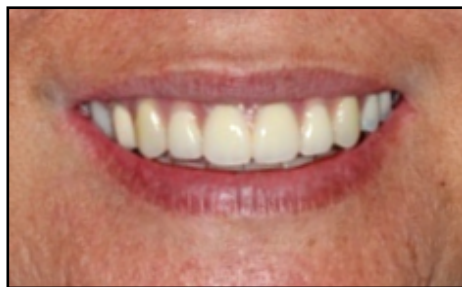
Figure 13 A beautiful smile of a satisfied patient. The treatment goal of restoring the chewing function and aesthetics was obviously achieved.
